NATIONAL PROGRAM FOR INSPECTION OF NON-FEDERAL DAMS
MOLCOTT DAM (VT 00179) (U) CORPS OF ENGINEERS WALTHAM
MA NEW ENGLAND DIV JUN 80

WOLCOTT DAM VT 00179

DOCUMENT IDENTIFICATION
JUNE 1980

Wolcott Dam - VT 00179
Wolcott, Vermont
May 6, 1980

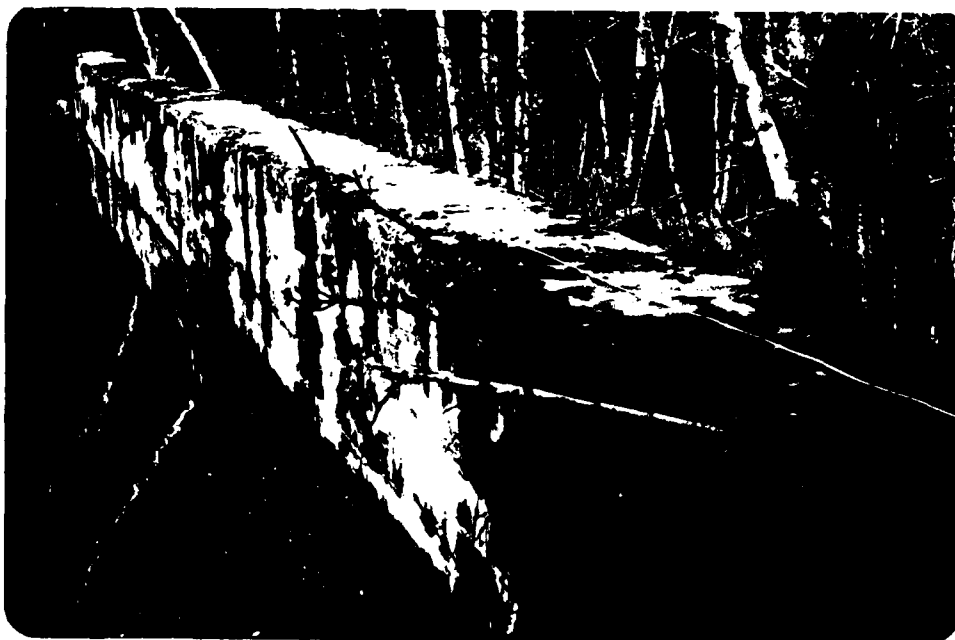
Moss and debris have accumulated on the outside of the dike wall in sufficient quantity to make observation of concrete condition and seepage sources difficult.

About 150 yards upstream of the dam site, on the right side of the reservoir, is a concrete dike 125 feet long, 3 feet across the top and 16 feet high at its highest point. The dike prevents by-passing of the dam by overflow from the reservoir via a gully through which the Lamoille Valley Railroad tracks pass. It appears in good structural condition with some spalling of the surface concrete.

(9) Concrete Dike Upstream of Dam
May 8, 1980

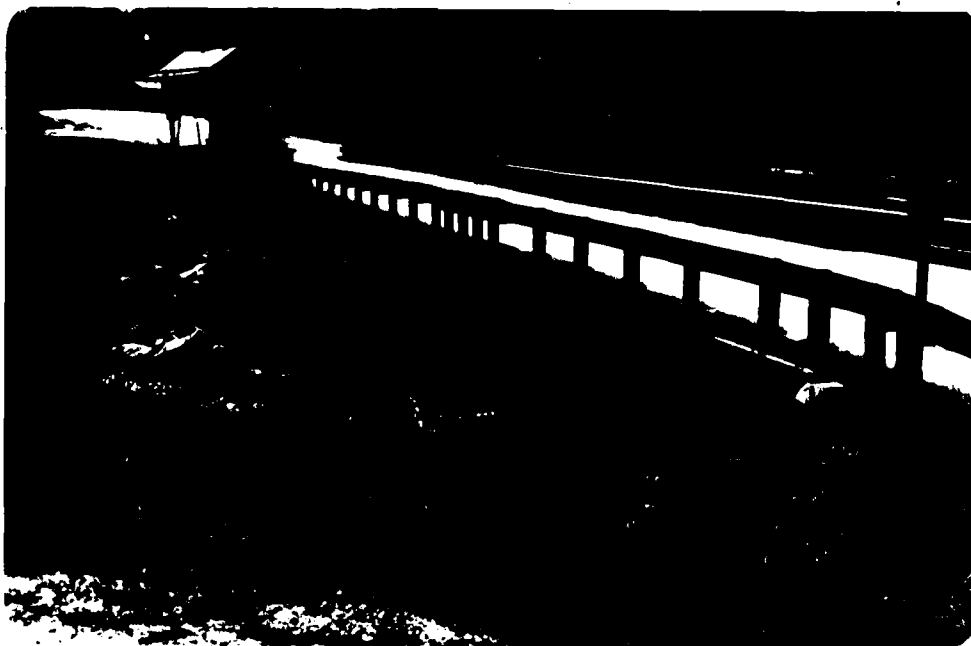
(13) Vermont Route 15 Bridges Downstream of Dam - May 8, 1980
